# Damp and Mould Inspection Form

Document No. 000305

Date of Inspection 21.02.2023 07:44 GMT

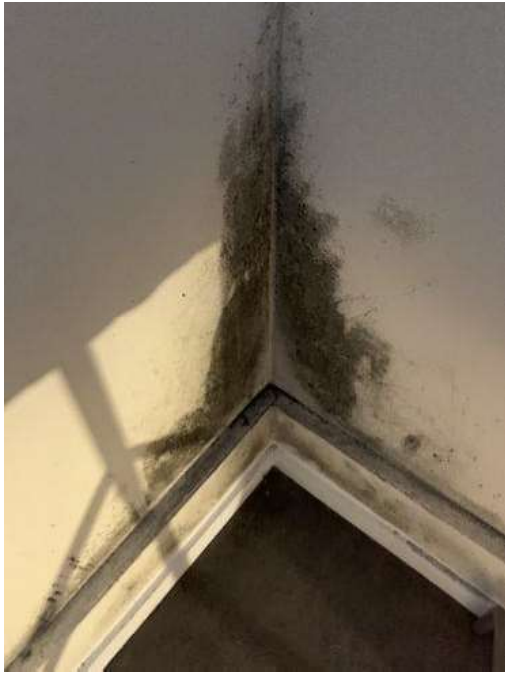
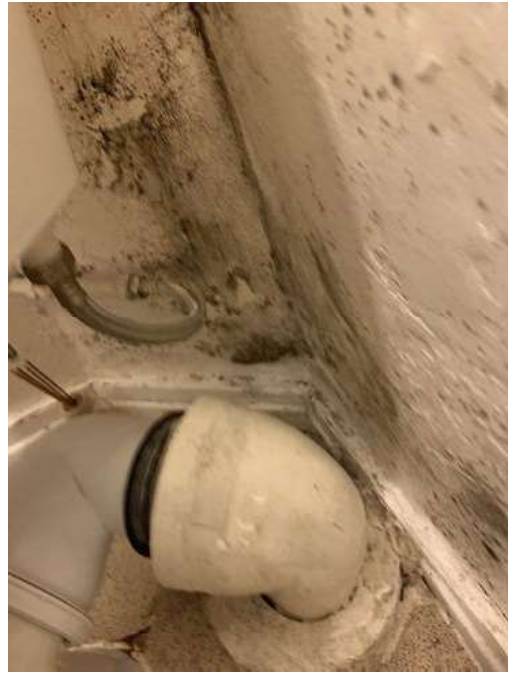
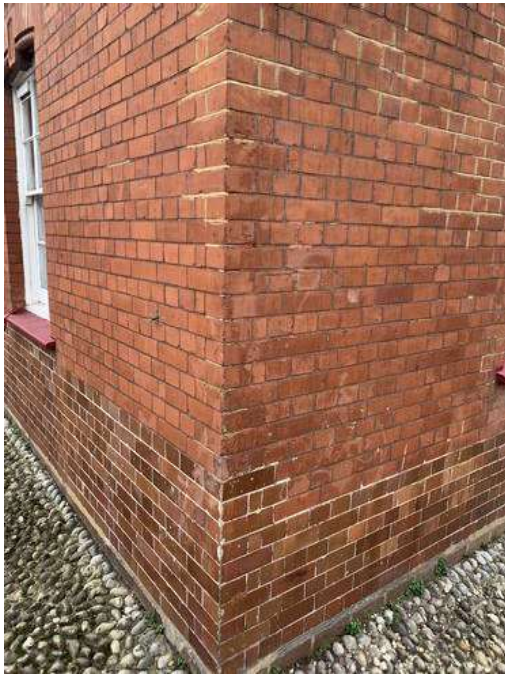
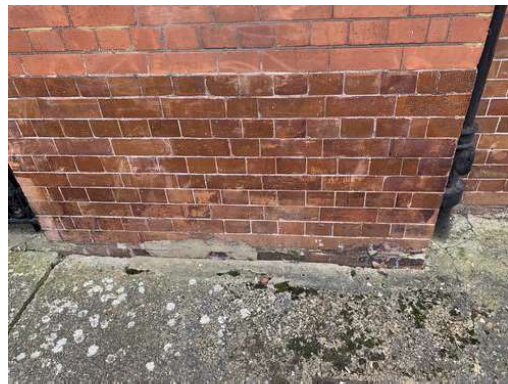
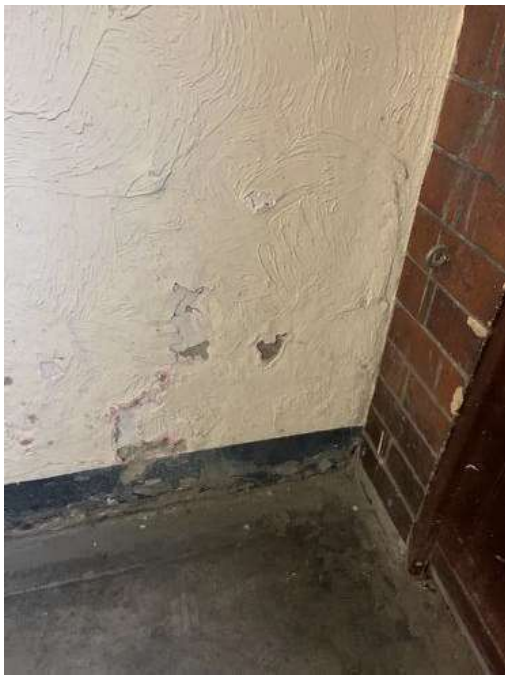
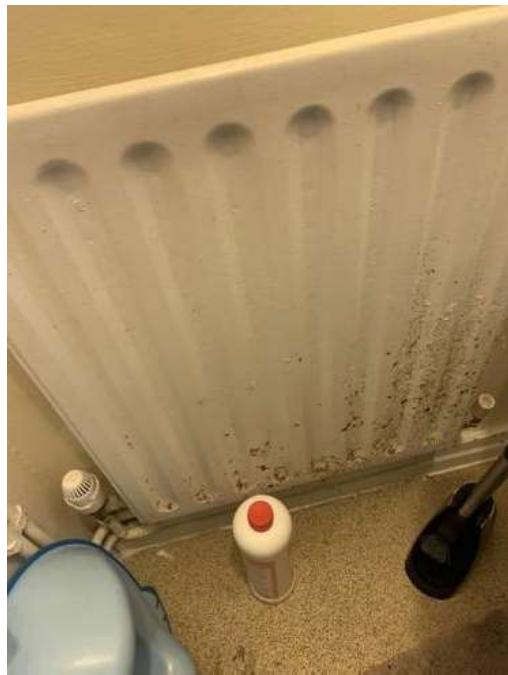
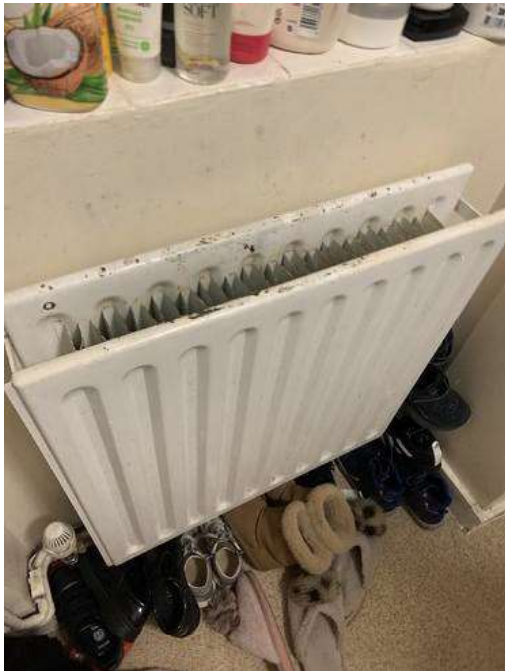
The issues maybe due to the exterior brickwork allowing moisture to access the property so, moisture boards will be required if the mould returns.

I would also suggest new radiators are installed

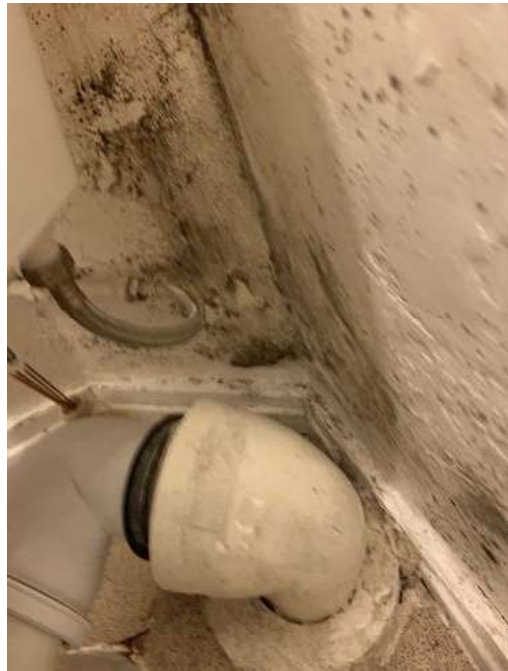
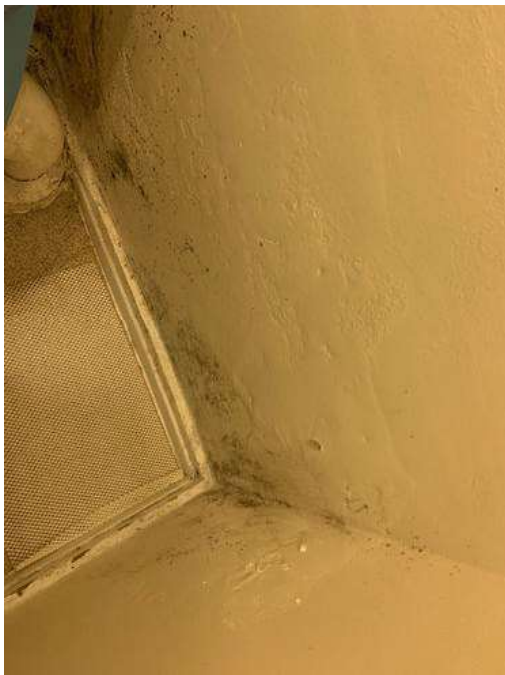
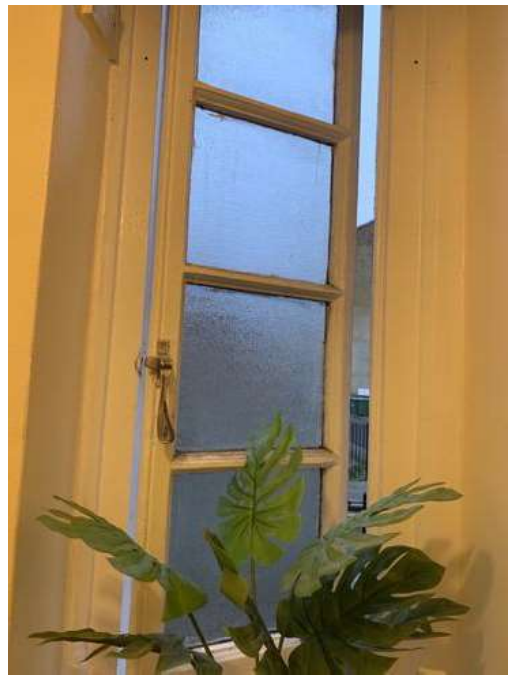
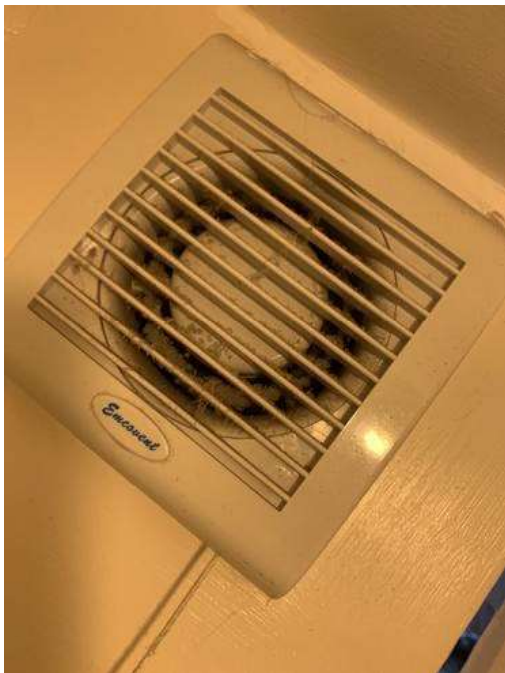
Toilet

Mould was located on the walls

Condition 2

Remove the mould and further remedial works maybe required

Remove the mould and clean and seal

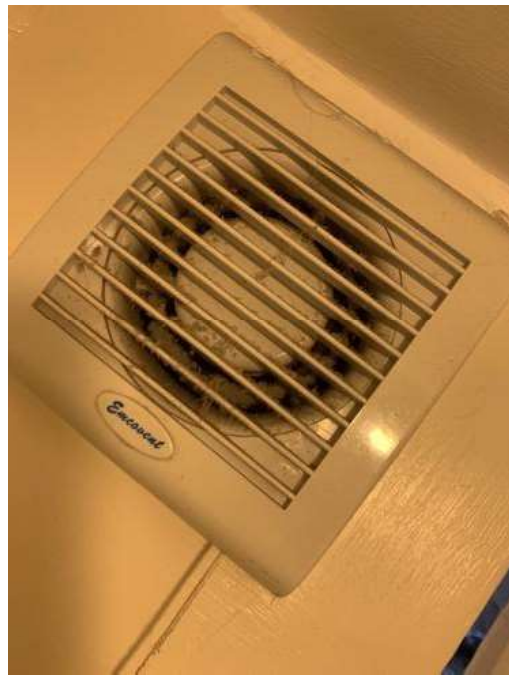
Photo 42

The airflow is low at 3l/s  
However it is blocked with dust and debris so will need to be cleaned

Clean the extract fan

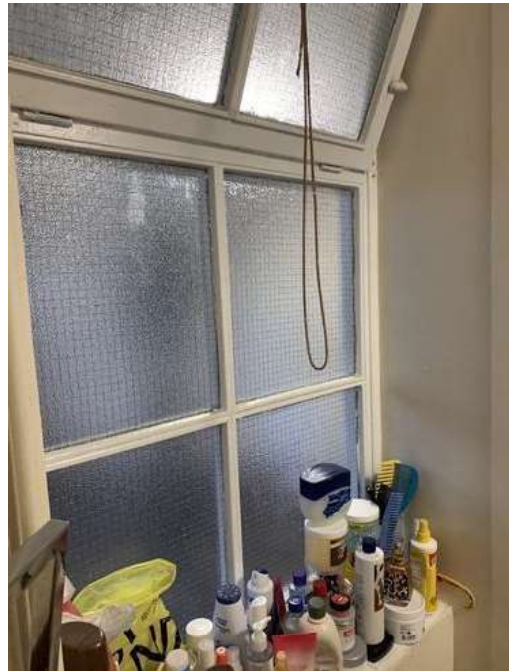
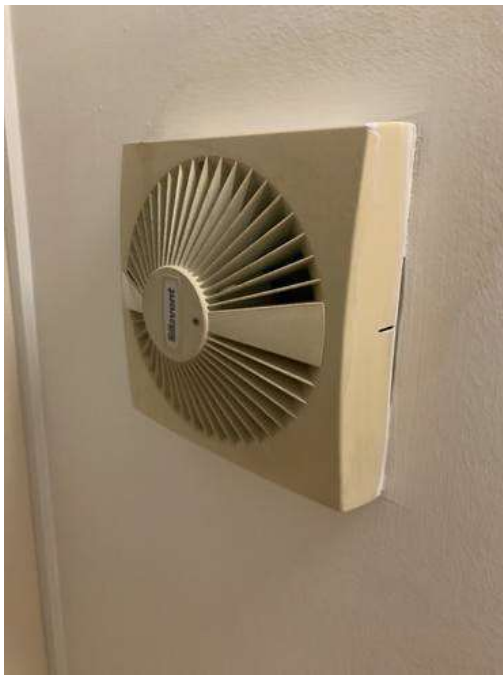
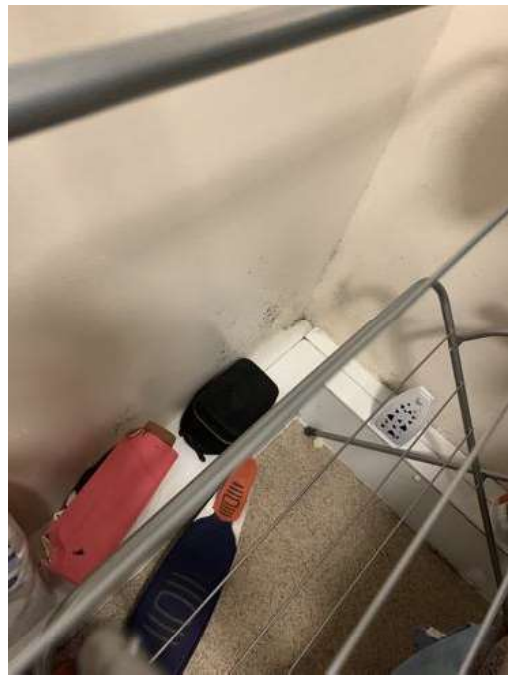
Bathroom

Mould was located on the wall

Condition 1

Remove the mould then clean and seal

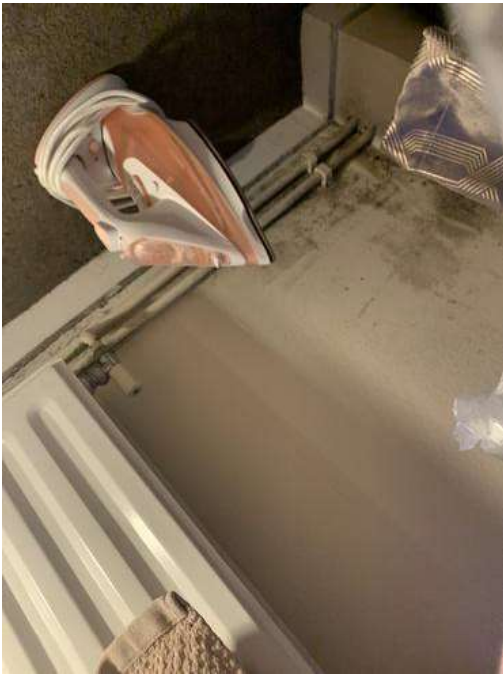
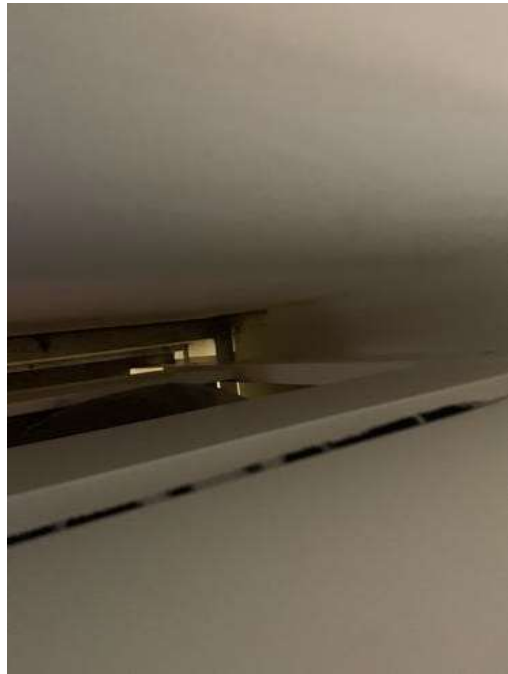
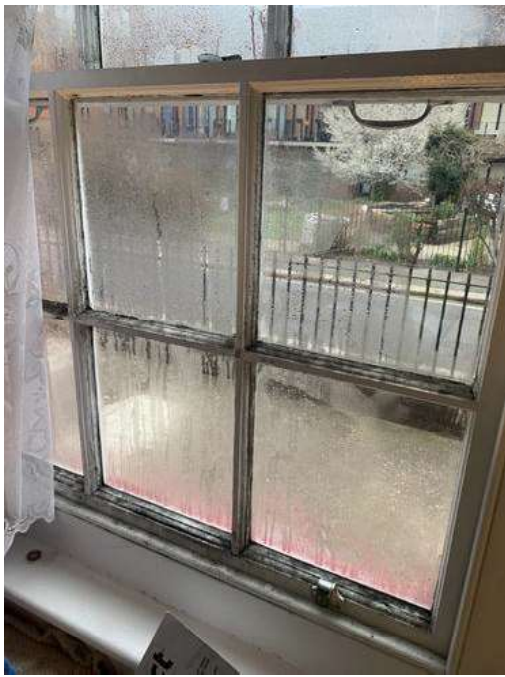
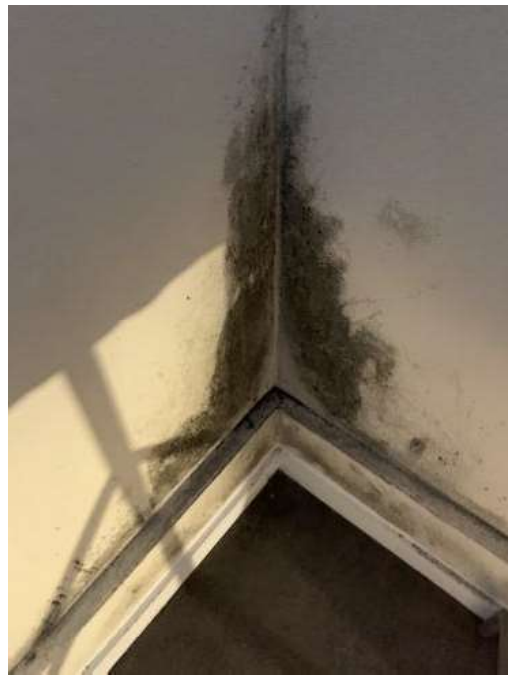
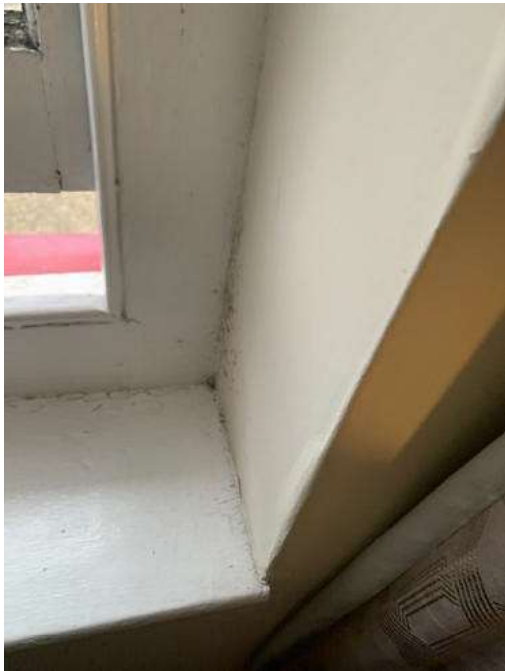
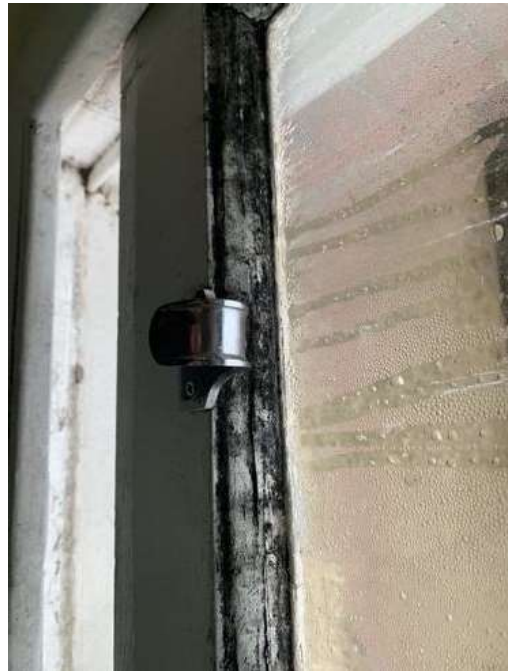
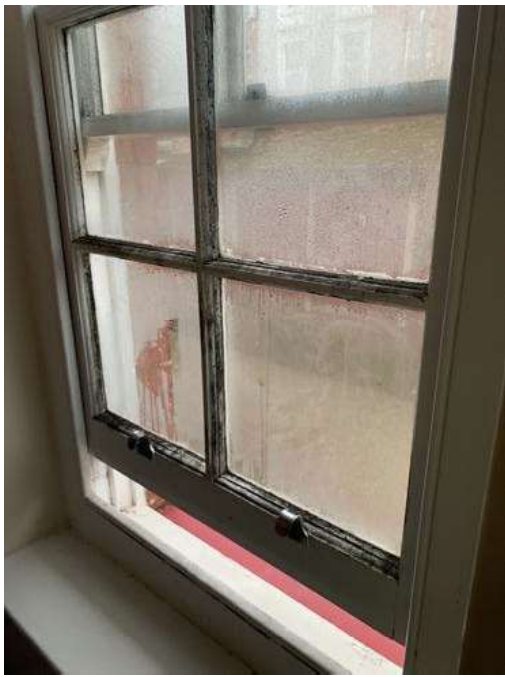
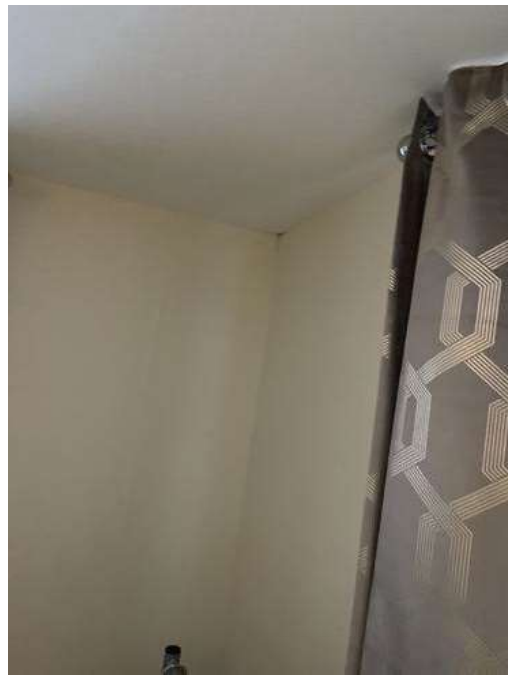
Bedroom

Mould was located on the walls and windows

Condition 3

Remove the mould then clean and seal
